Bathing Water Profile for Millport Bay

Great Cumbrae, Scotland

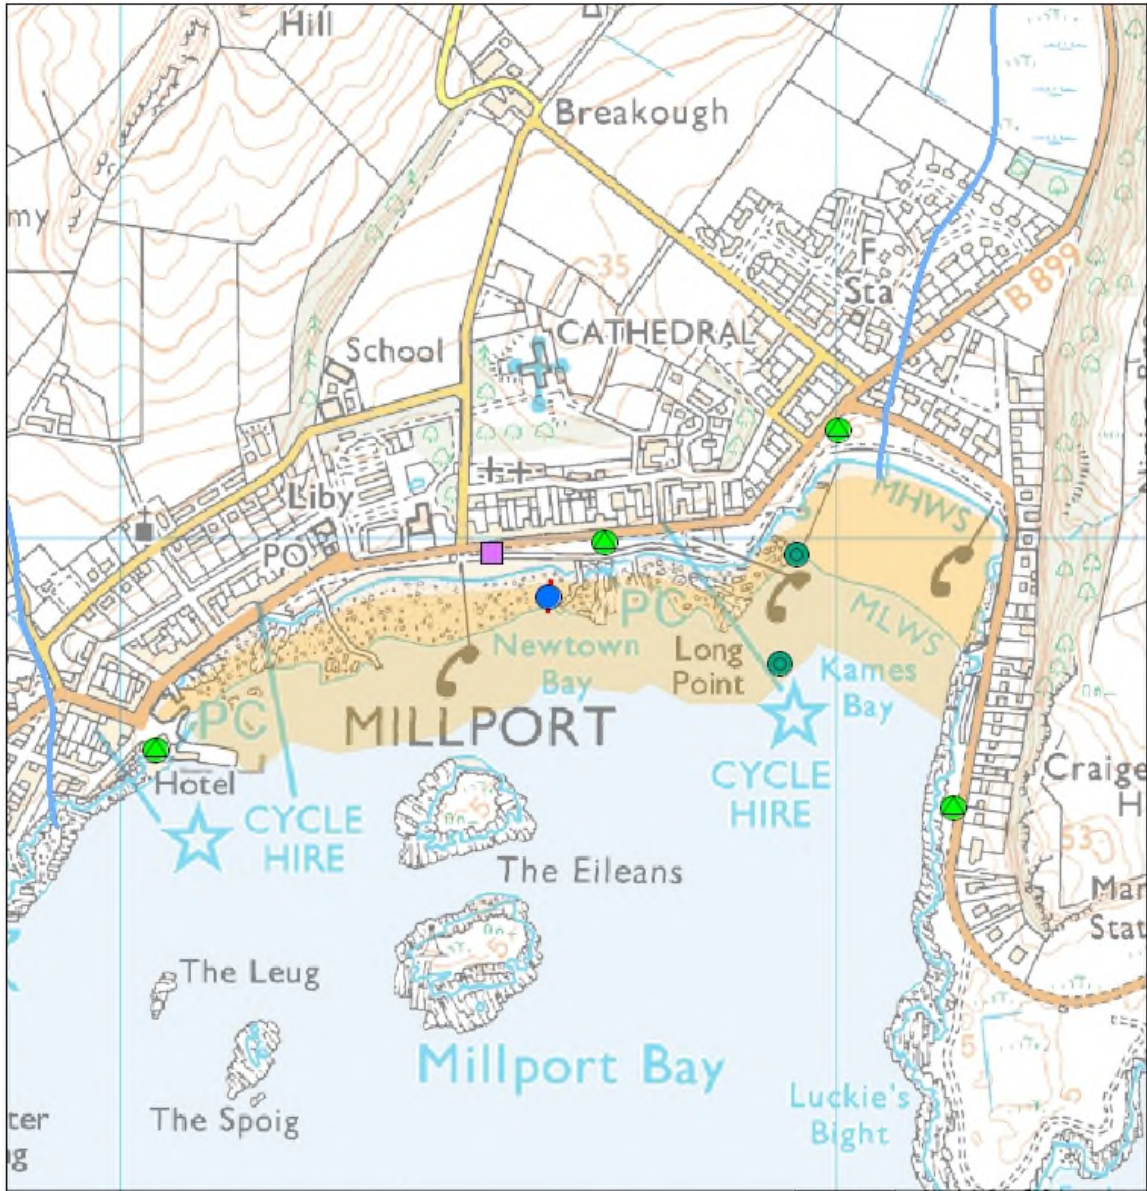
Map 1: Millport Bay bathing water

<p>© 2010 Scottish Environment Protection Agency. This map is reproduced from Ordnance Survey material with the permission of Ordnance Survey on behalf of the Controller of Her Majesty's Stationery Office ©Crown Copyright . Any unauthorised reproduction infringes Crown copyright and may lead to prosecution or civil proceedings. SEPA lic. no. 100016991 (2010). Some features of this map are based on digital spatial data licensed from the Centre for Ecology and Hydrology, © CEH.</p>			
<ul style="list-style-type: none"> Designated bathing water Bathing water sampling point Bathing water sampling transect SEPA electronic sign Surface water discharge Sewage pumping station Watercourses

The principal risks and source of wet weather driven short term pollution at this bathing water arise from overflows from the sewerage system, urban drainage and agricultural run-off.
