Bathing Water Profile for Portobello (West)

Edinburgh, Scotland

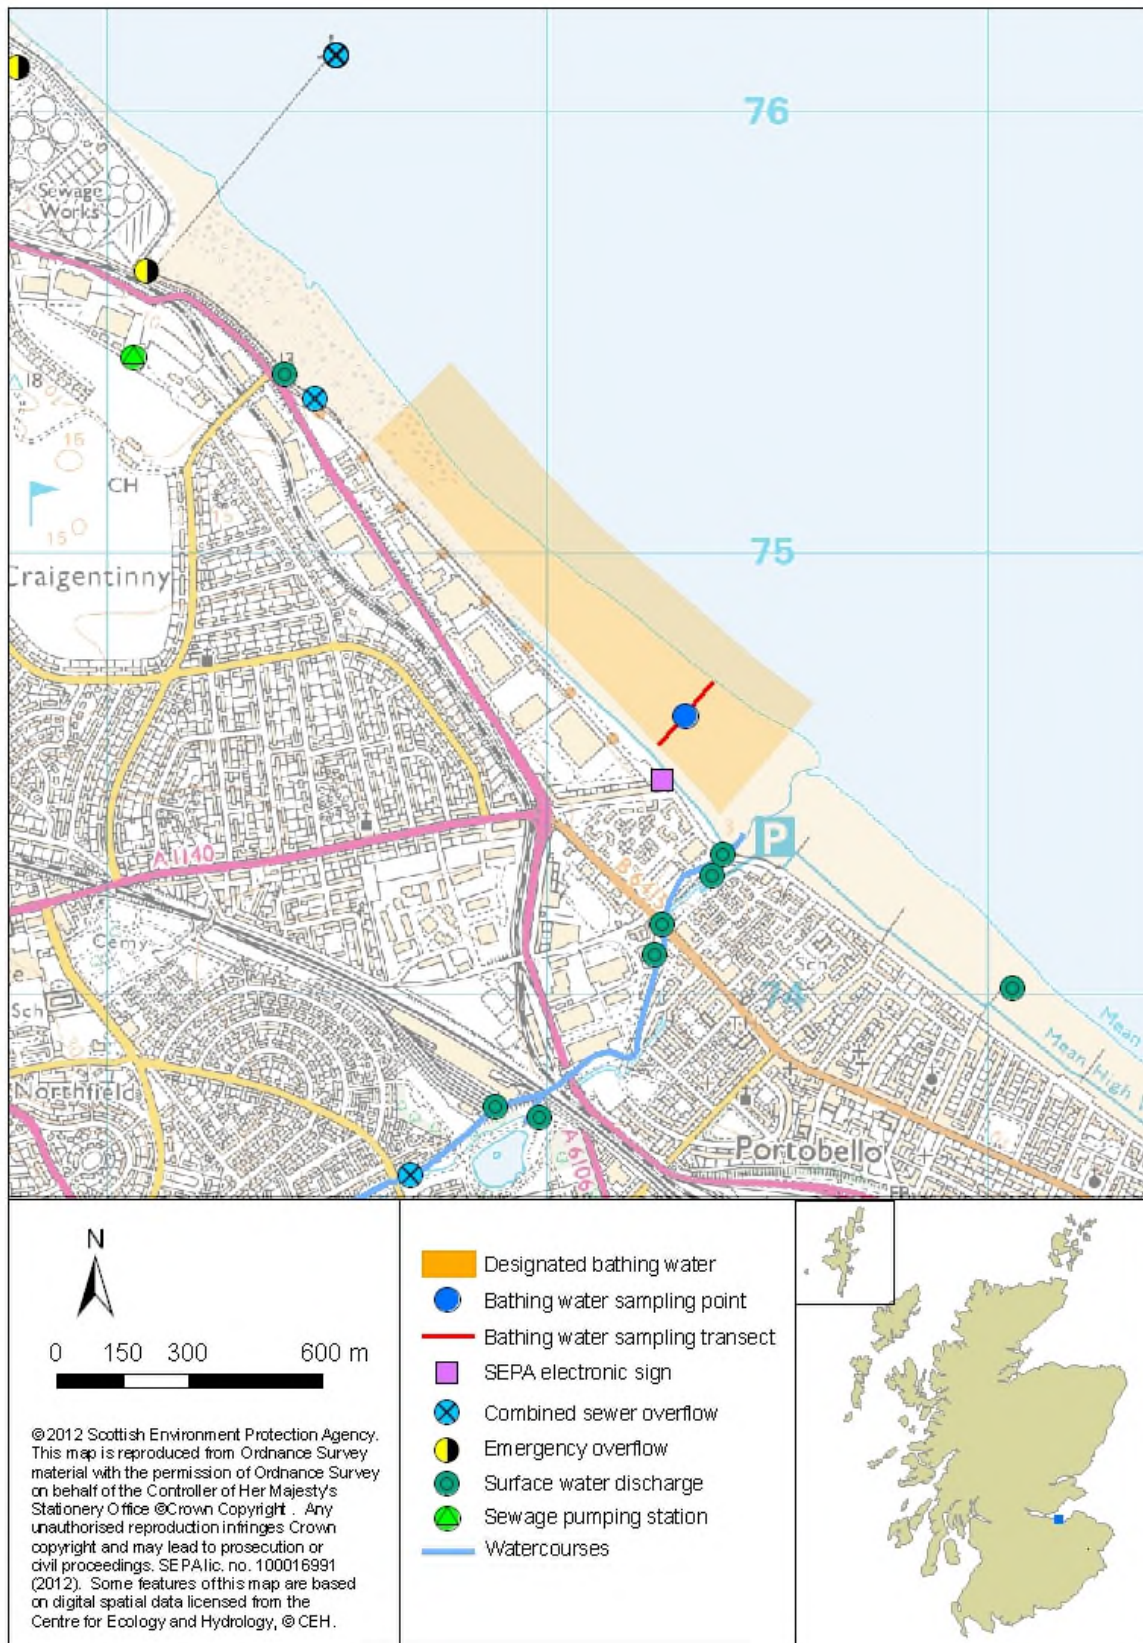
Map 1: Portobello (West) bathing water

This bathing water is subject to short term pollution when heavy rainfall washes bacteria into the sea. Pollution risks include combined sewer overflows and surface water outfalls. These are highlighted on Map 1.

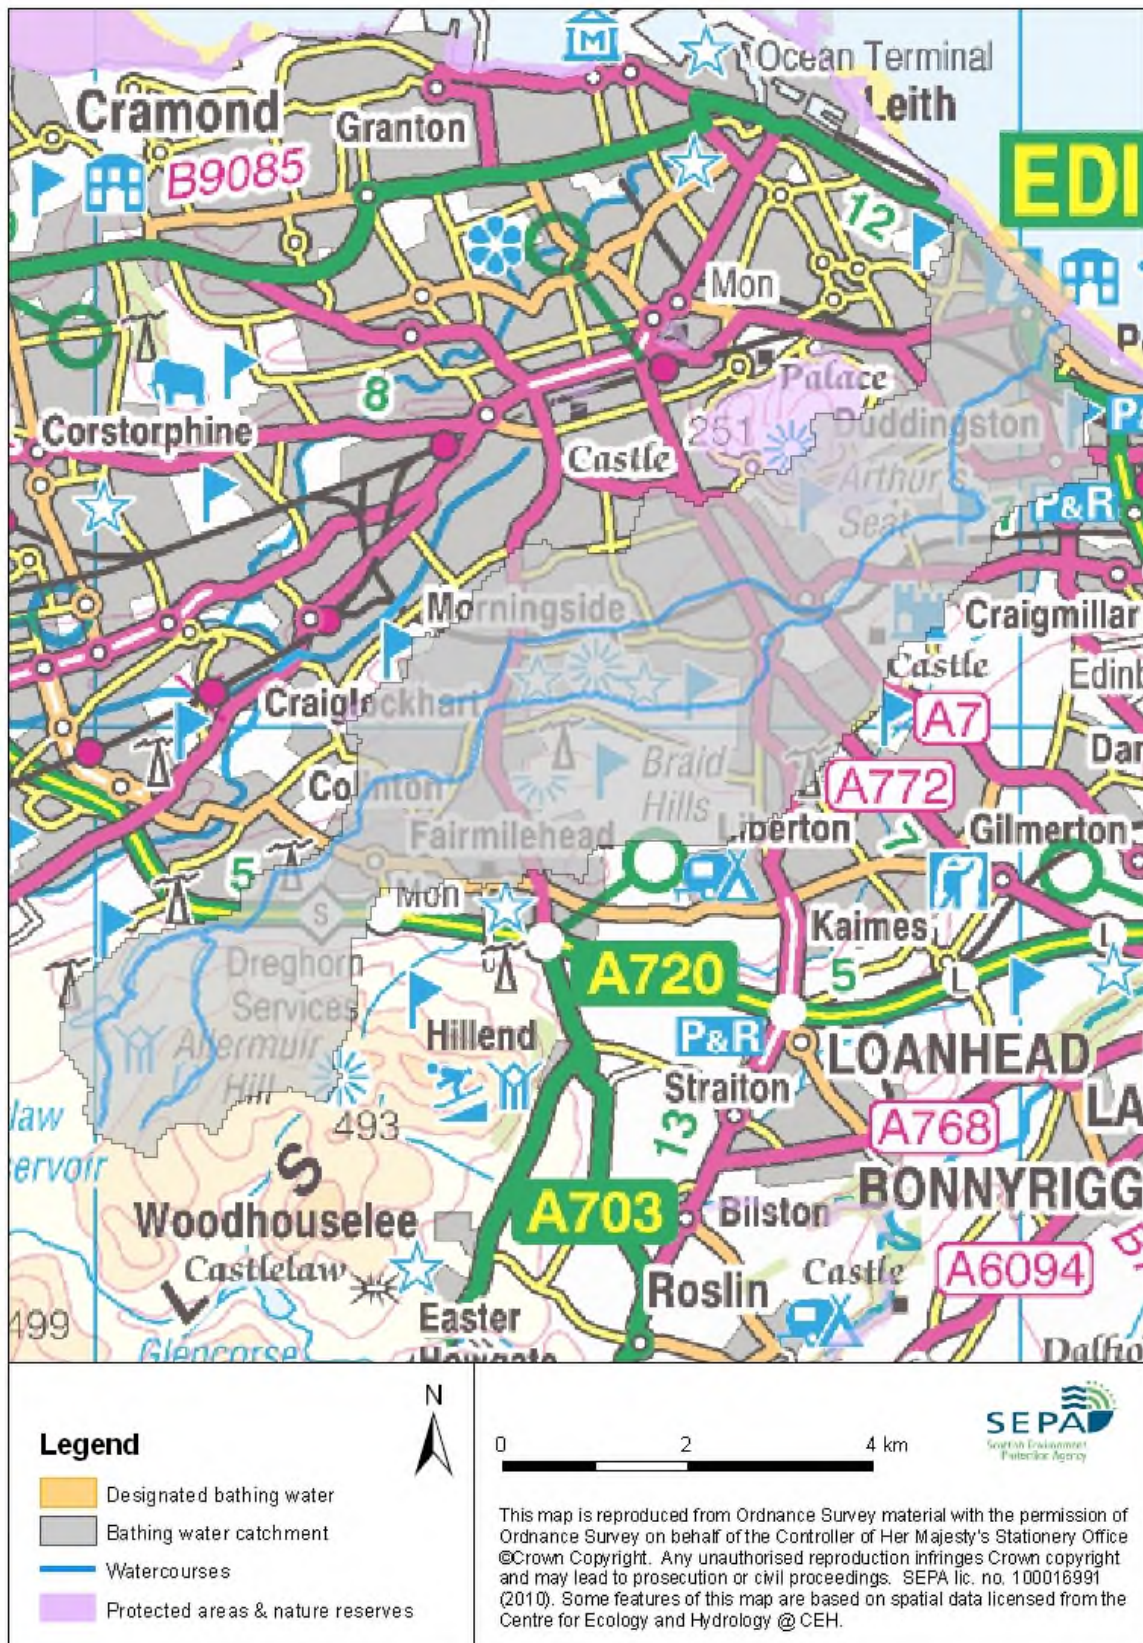
Map 2: Catchment draining into Portobello (West) bathing water

A catchment area of 32 km² drains into Portobello (West) bathing water.

Land use is split between urban and rural uses. Portobello town and the south of Edinburgh are the main urban areas within the catchment.

The main river in the bathing water catchment is the Braid Burn/Figgate Burn. It flows into the sea between Portobello (West) and Portobello (Central) bathing waters.
