Bathing water profile:

Saltcoats/Ardrossan

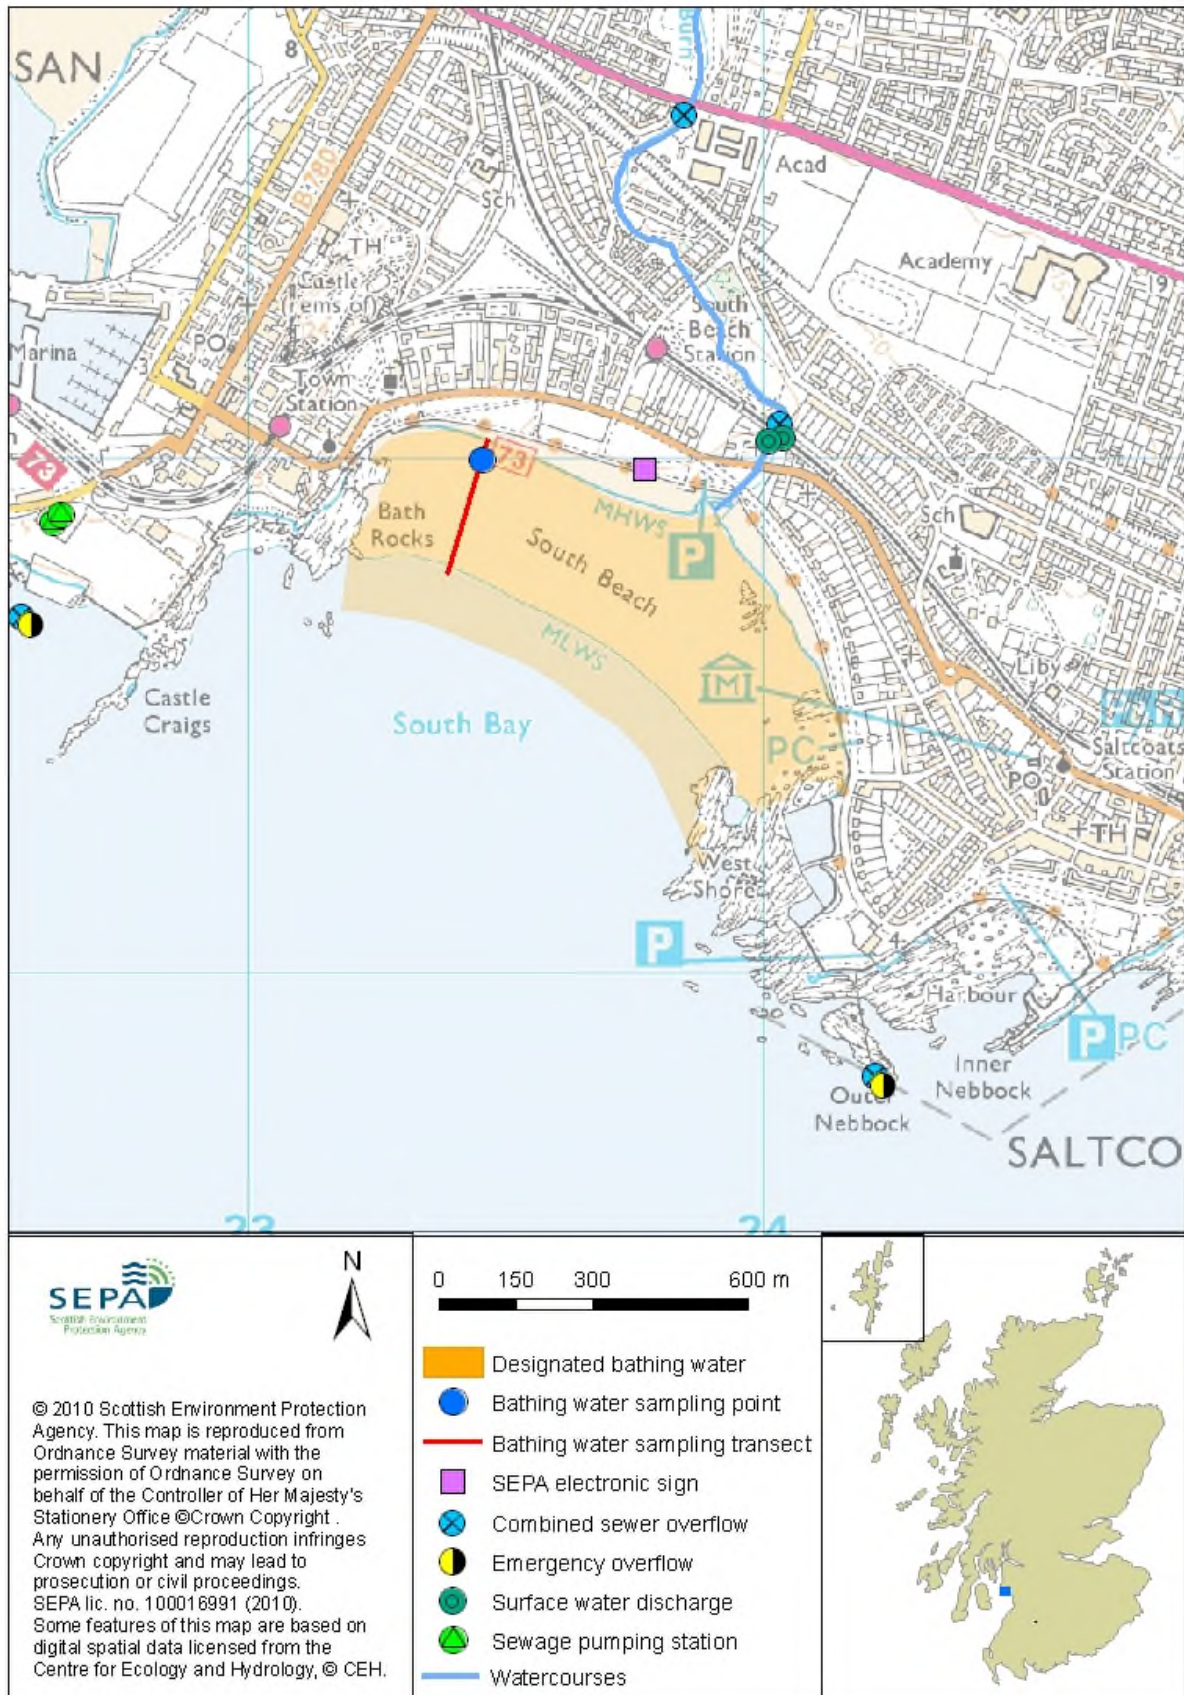
Map 1: Saltcoats/Ardrossan bathing water

<p>EC bathing water ID number: UKS7616049</p>	
<p>Location of bathing water: UK/Scotland/North Ayrshire (Map1)</p>	
<p>Year of designation: 1987</p>	
<p>Photograph provided courtesy of North Ayrshire Council</p>	
<p>Bathing water description</p> <p>Saltcoats/Ardrossan bathing water is a 1 km stretch of sandy beach that lies between the towns of Ardrossan and Saltcoats on the North Ayrshire coast. There are rocky areas at Bath Rocks in the north-west and at the former boating ponds in the south-east. The nearby island of Arran can be seen to the west of the bathing water. The bathing water is also known locally as South Beach. It was designated as a bathing water in 1987.</p> <p>During high and low tides the approximate distance to the water's edge can vary from 0–390 metres. The sandy beach slopes gently towards the water. For local tide information see: http://easytide.ukho.gov.uk/EasyTide/</p> <p>Our monitoring point for taking water quality samples is located at the western end of the designated area (Grid Ref NS 23453 41997) as shown on Map 1.</p>

The potential relevant pollution sources at, or near, this bathing water are highlighted on Map 1.

Throughout the bathing season we display daily water quality predictions on the electronic message sign (Map 1). These water quality predictions are also available on our [website](#)³ or via the Beachline phone number (08452 30 30 98).

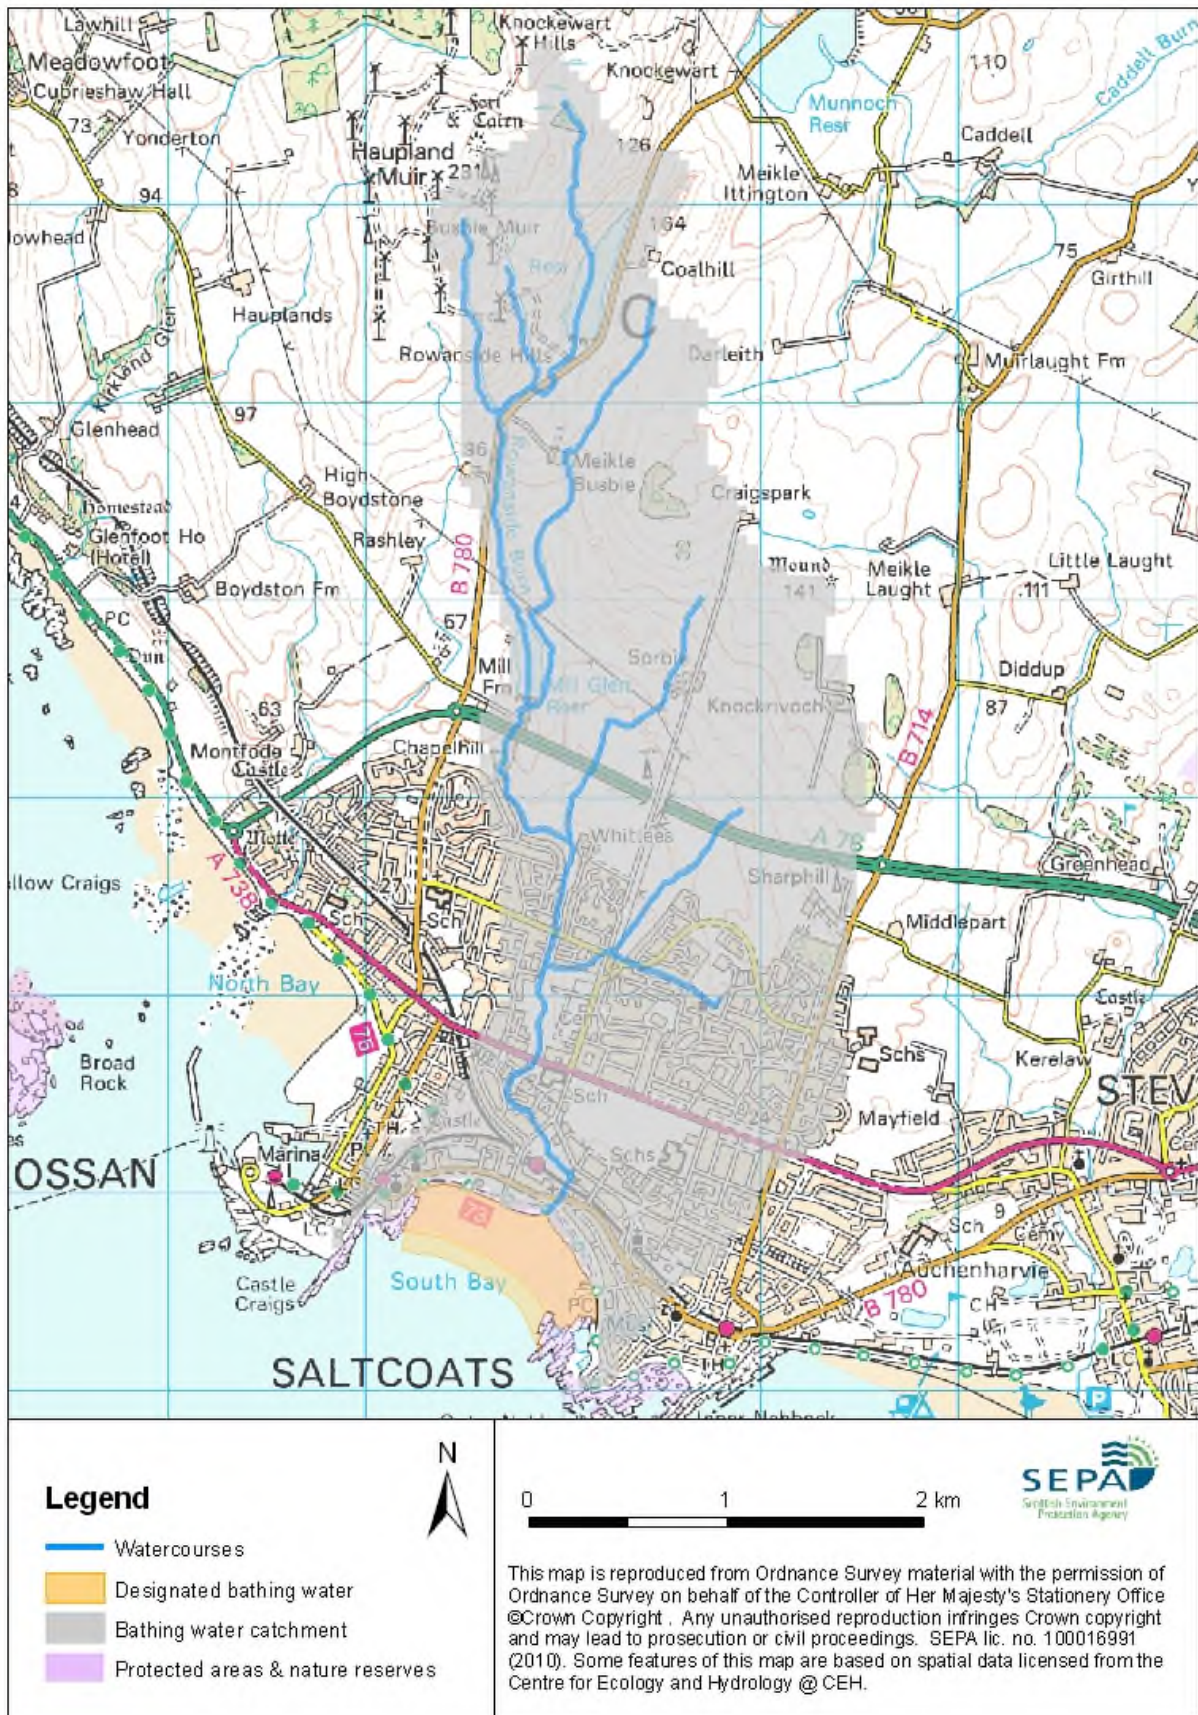
Map 2: Catchment draining into Saltcoats/Ardrrossan (bathing water)

The main water course draining the catchment is the Stanley Burn which flows discharges into the Firth of Clyde at the designated bathing water midway along the beach at Burn Road (see Map 2).

Horse Isle, an RSPB nature reserve home to nationally important bird populations such as Herring Gulls and Lesser Black Backed Gulls (Map 2), is to the north-west of the bathing water.

The catchment draining into the Saltcoats/Ardrossan bathing water extends to 9 km². The area varies in elevation from the hills in the north/north-west (maximum elevation 370 metres) to lowlands around the towns of Saltcoats and Ardrossan (elevation 0– 60 metres) along the coast.
