Bathing Water Profile for Southernness

Southernness, Scotland

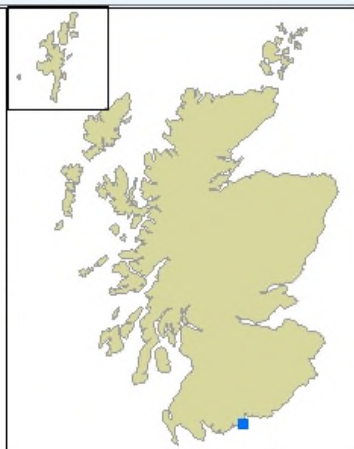
Map 2: Catchment draining into Southernness bathing water

The immediate catchment draining to the Southernness bathing water extends to just under 7 km². The area varies in elevation from a maximum of 200 metres in the north to an average of 10 metres along the coast. There are two coastal burns within this catchment, one of which drains directly into the designated area.

The immediate bathing water catchment is predominantly rural (97%) with grassland the major land use. The area supports some, but not many, dairy and beef cattle as well as arable production. Approximately 1% of the immediate catchment is urban with the main population centre, Southernness village, adjacent to the bathing water. Population density out with the village is low comprising of a few scattered farms and houses.

The bathing water sits within the Upper Solway flats and marshes which is a Ramsar site, a Special Area of Conservation), a Site of Special Scientific Interest and a Special Protected Area (Map 2).
